Enclosure No 1
to
Bulletin No BO-112/2005 SWIFT S-1

**WORKING INSTRUCTION
INSPECTION OF CONTROL COLUMN
IN ELEVATOR CONTROL SYSTEM
OF SWIFT S-1 GLIDER**

**This a.m. document has been adopted at Zakłady Lotnicze for the purpose of
Bulletin No BO-112/205 SWIFT S-1.**

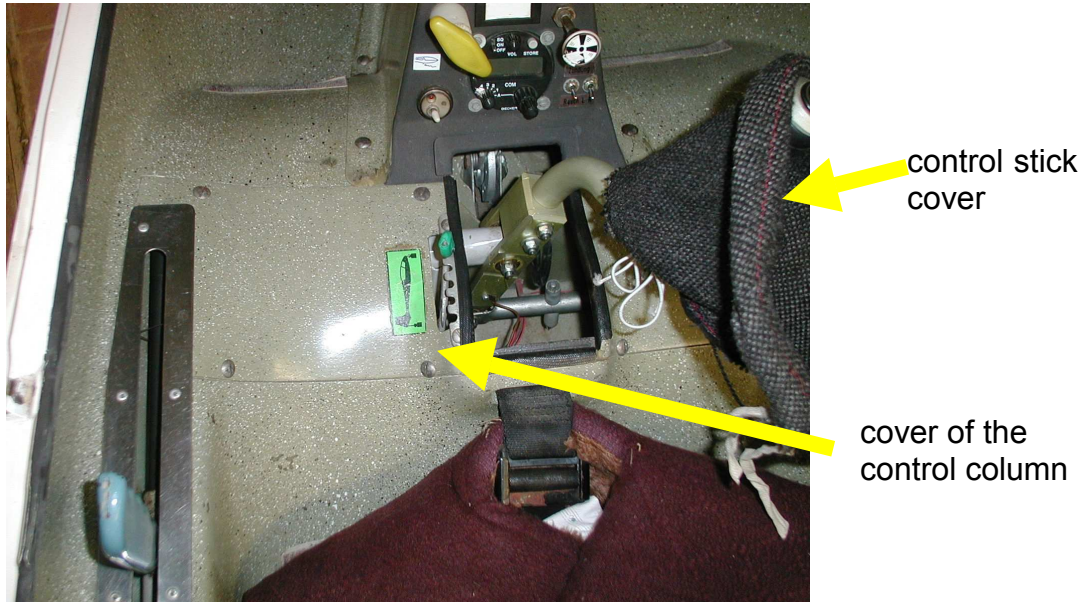
picture 1: Cover of the elevator controls

- I) Dismantle the control stick cover and remove the left (in flight direction) access cover of the controls close to the control stick (s. picture 1).
- II) Inspect the welding seams of the attachments (see circles in picture 2) over the whole length for cracks and other damage; use a strong pocket lamp and a mirror - if necessary. If crack or other damage is found, the control column must be replaced.

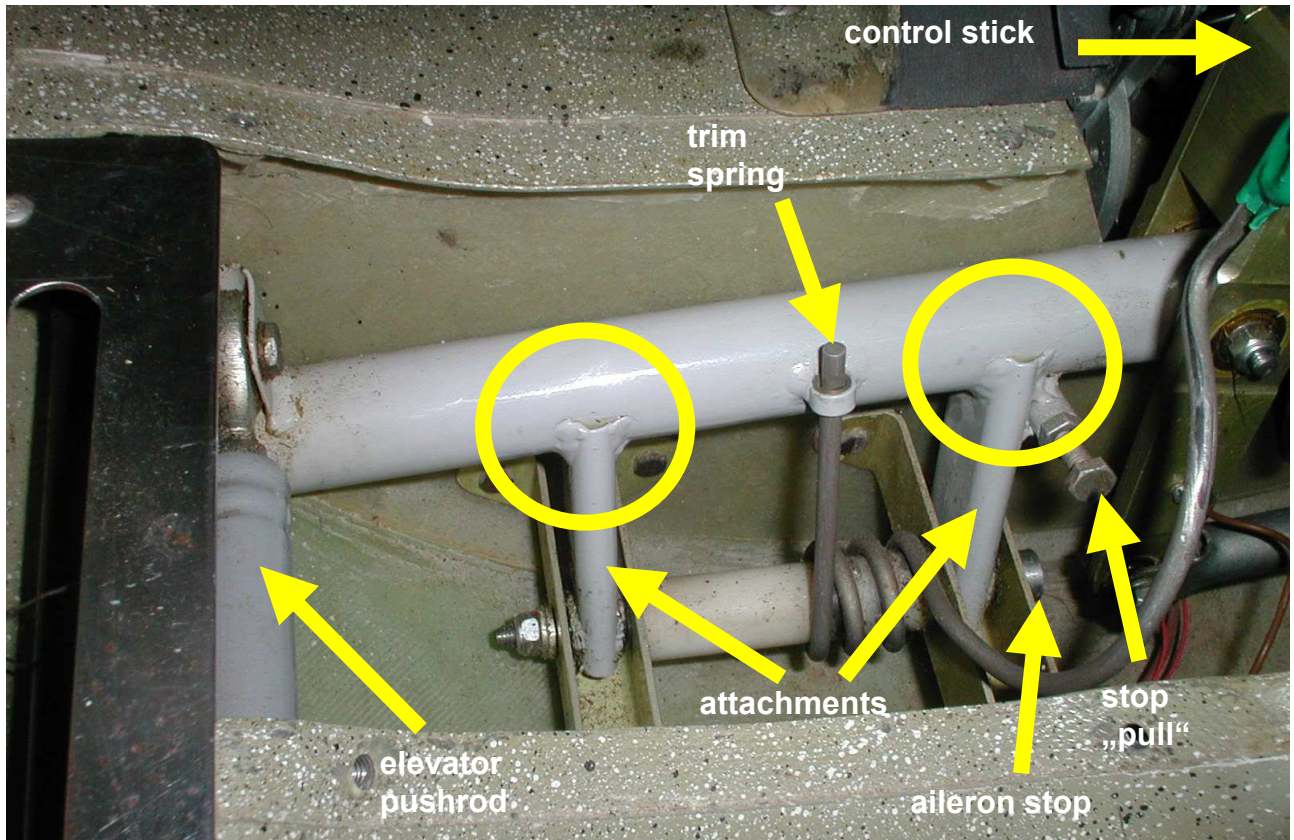
picture 2 : Elevator control column

When exchanging the elevator control column, pay special care to the bolt mounting the column with its bearings, as the head of this bolt is at the same time the stop for the aileron (see picture 2). Therefore it is necessary that the washers and spacers (if installed) are fitted at the same position when the new column is assembled.

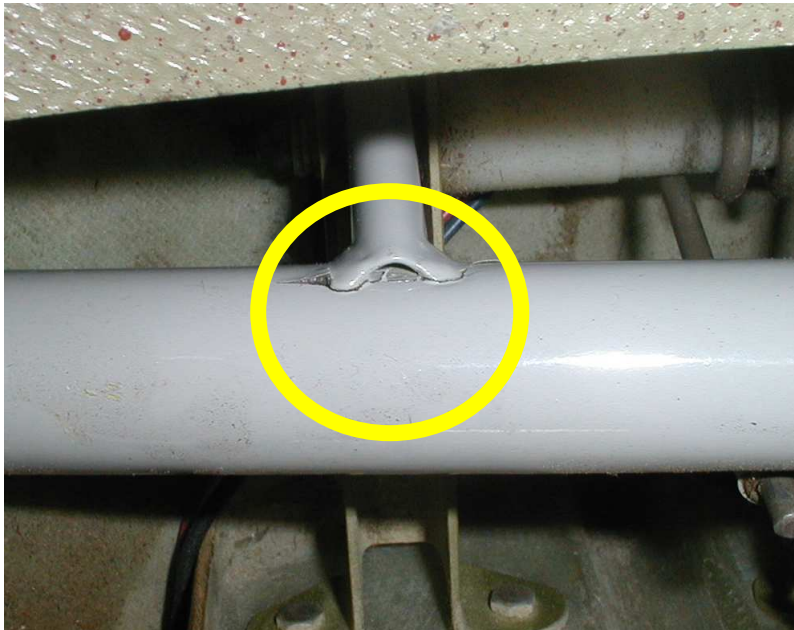
picture 3: Damage viewed from front

picture 3 and picture 4 show a sample of the possible damage.

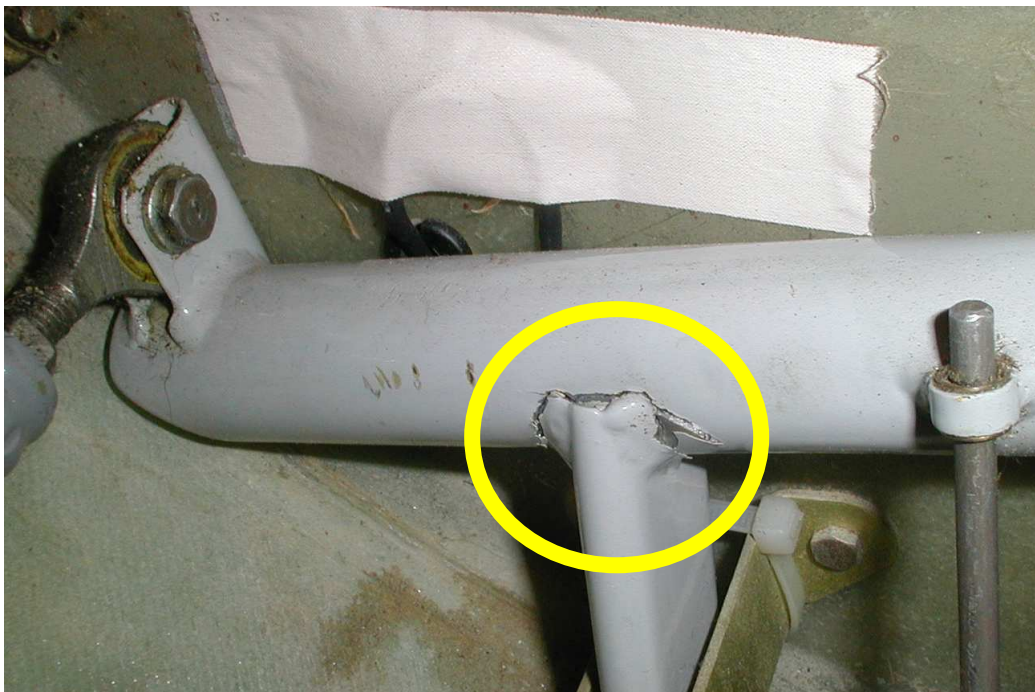
picture 4: Damage viewed from behind

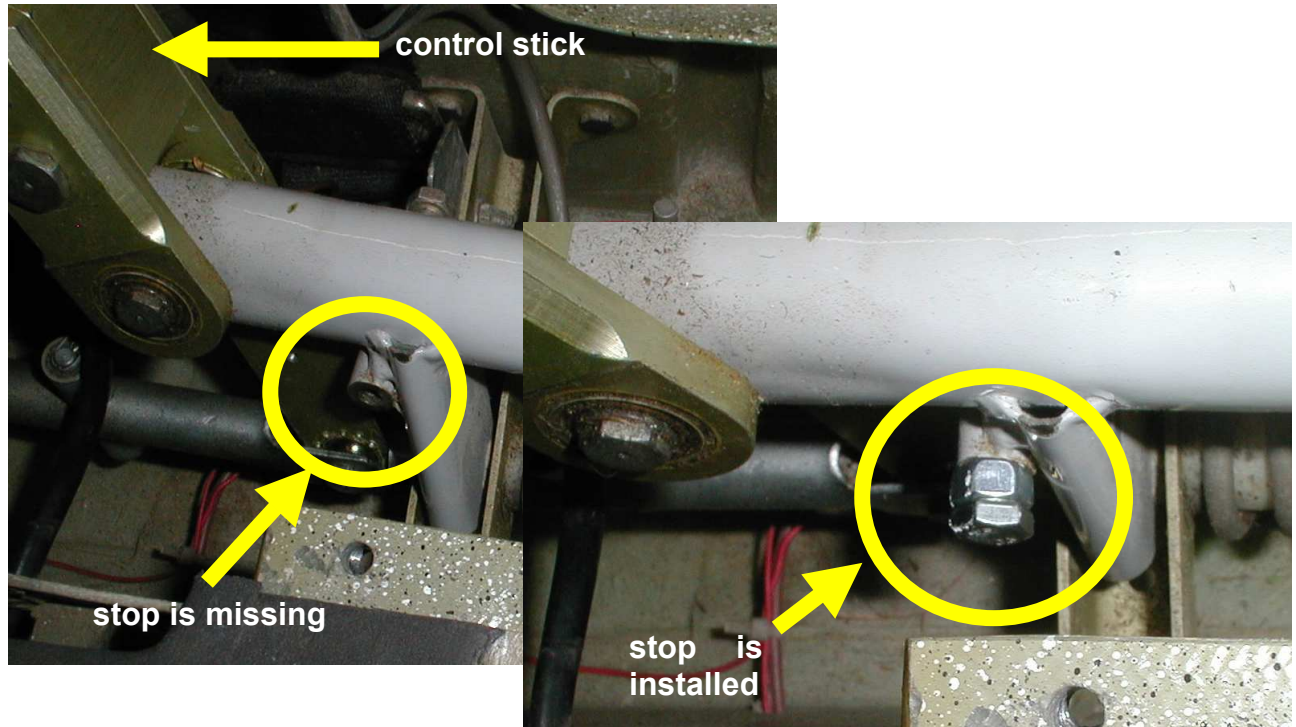
- III) Check if a stop is installed on the control column for the „nose down“ (push) position. If no stop (bolt M6) is found, this must be retrofitted according to part 2 of this Working Instruction.

picture 5: Check of the stop for elevator „nose down“ (viewed from front)

The bolt M6 x 20 must be screwed into the existing thread on the front face of the control column and locked with the nut M6 (see picture 5).

The bolt must be screwed in at least 10mm deep into the thread of the column.

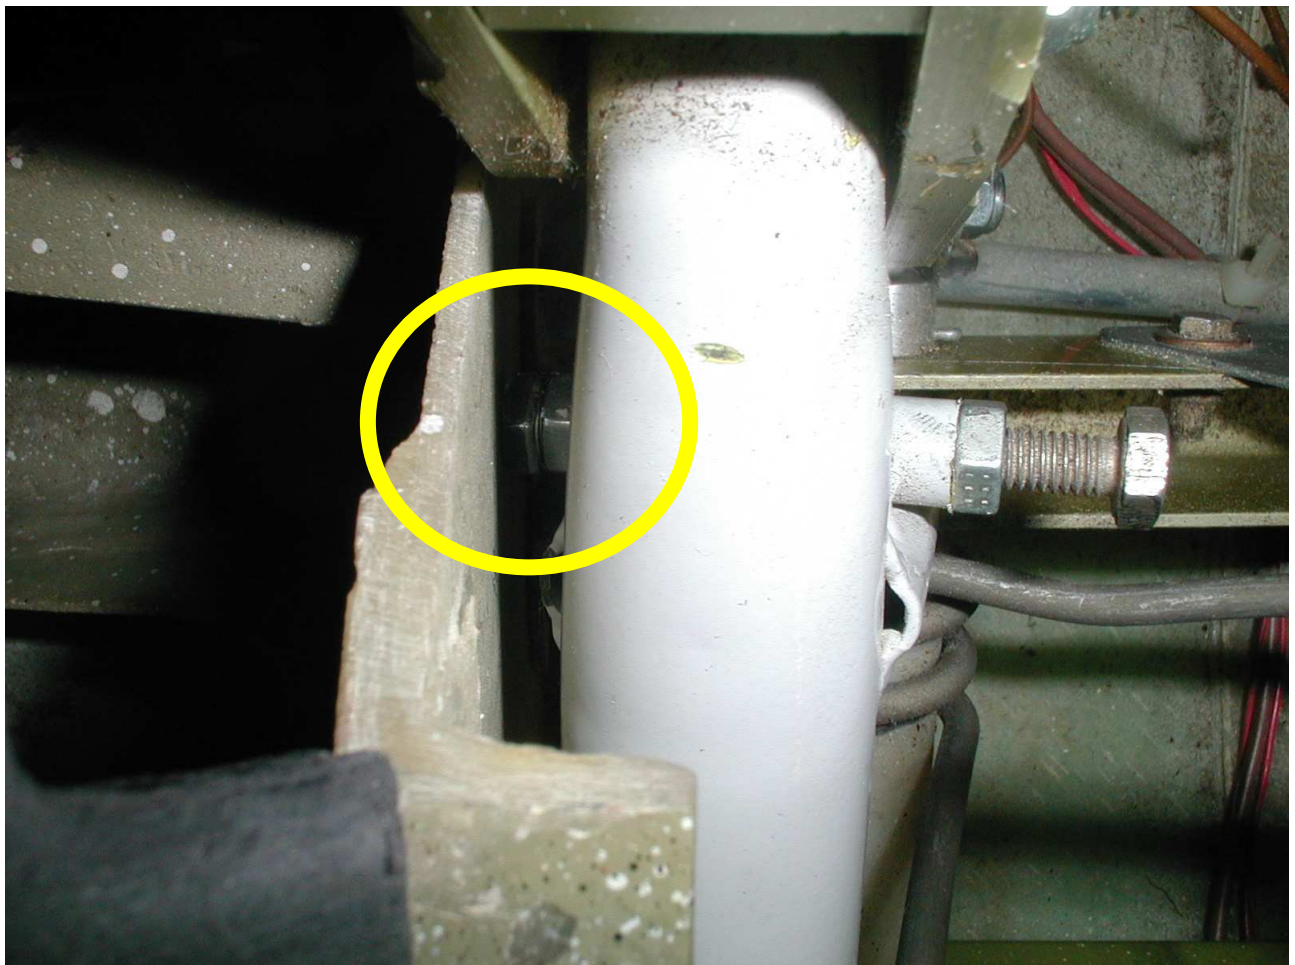
picture 6: Control column pushed fully forward until the stop

The head of the stop bolt must be adjusted so to hit the front control bulkhead prior to the contact between attachment of the elevator push rod at the outer side (sheet metal-U, see picture 7) and GFRP frame!

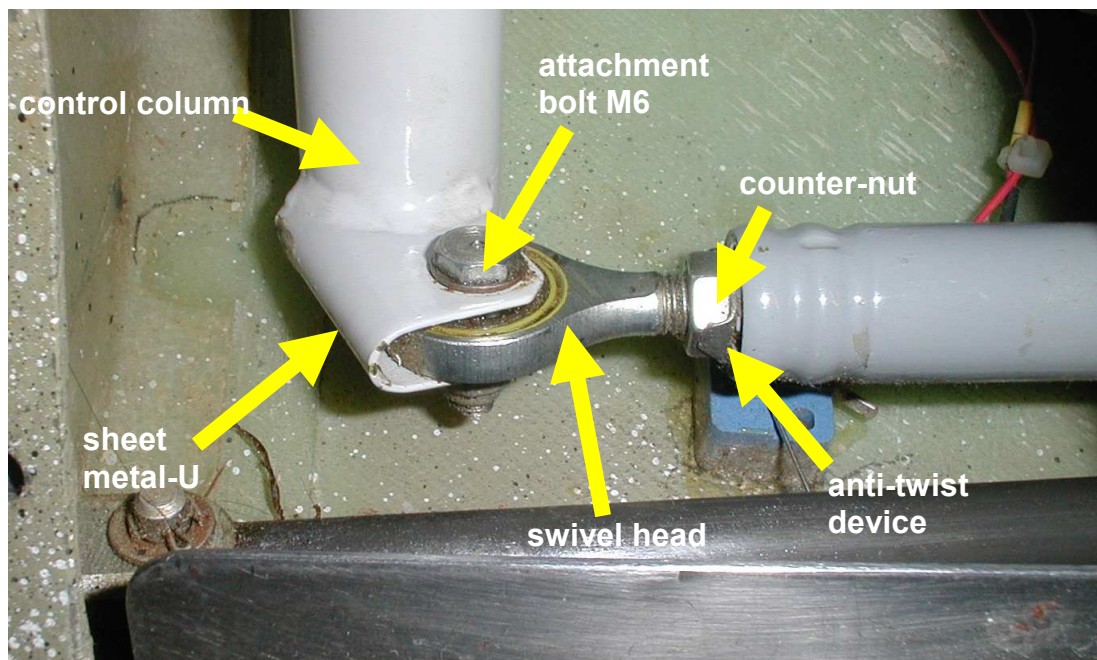
picture 7: Swivel-head at the elevator pushrod fixed by a locknut and secured

To do so, untighten and disconnect the bolt M6, one connecting the push rod end with the column, mark the positions of the washers and keep all these items. Bend off the anti-twist lock at the counter-nut (sheet metal clip), unthighten the counternut and screw the swivel head into the pushrod until the elevator deflections in „nose down“ direction reach the required value (see picture 7 and picture 8).

Finally, tighten the counter-nut of the swivel-head and secure it against loosening with the anti-twist device. Connect the pushrod with the control column by means of the M6 bolt, use the washers as marked when disassembling the set. Use a new lock nut M6.

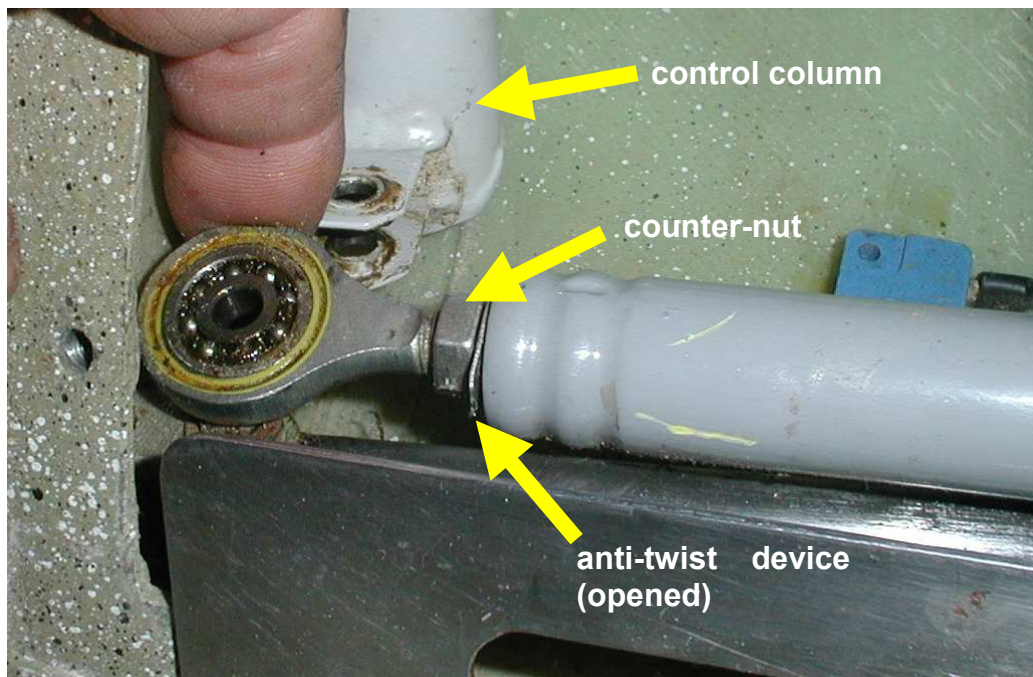
picture 8: Swivel-head disconnected and counter-nut untightened
