To install a canopy guiding device which accomplishes the same task as the so called „Rögerhaken“ on a „**Swift S-1**“ glider the following materials are necessary:

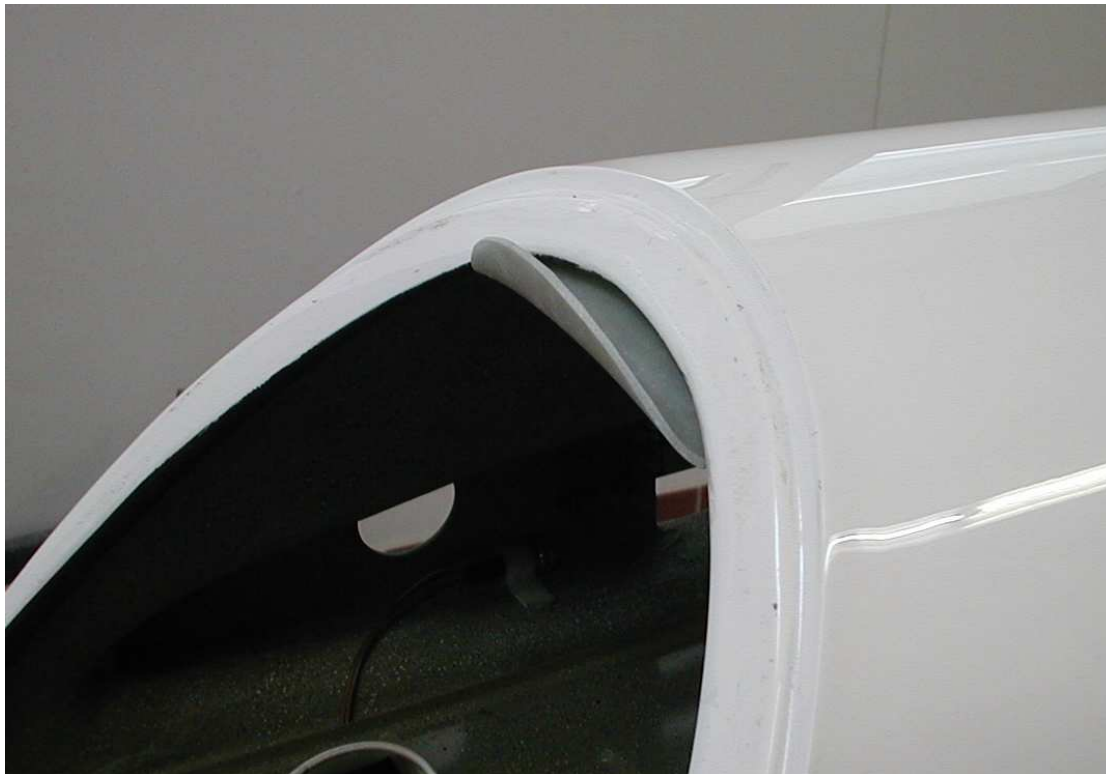
**Fig. 1: Confirmation of proper fit of part S1 R1**

Prior to glueing the part **S1 R1** into the fuselage its proper fit must be confirmed. To do so place it symmetrically in the upper canopy frame as shown in Fig. 1. Push it to the front as far as possible and temporarily fixate it there e.g. by an assistant who reaches through the spar-fork opening in the fuselage.

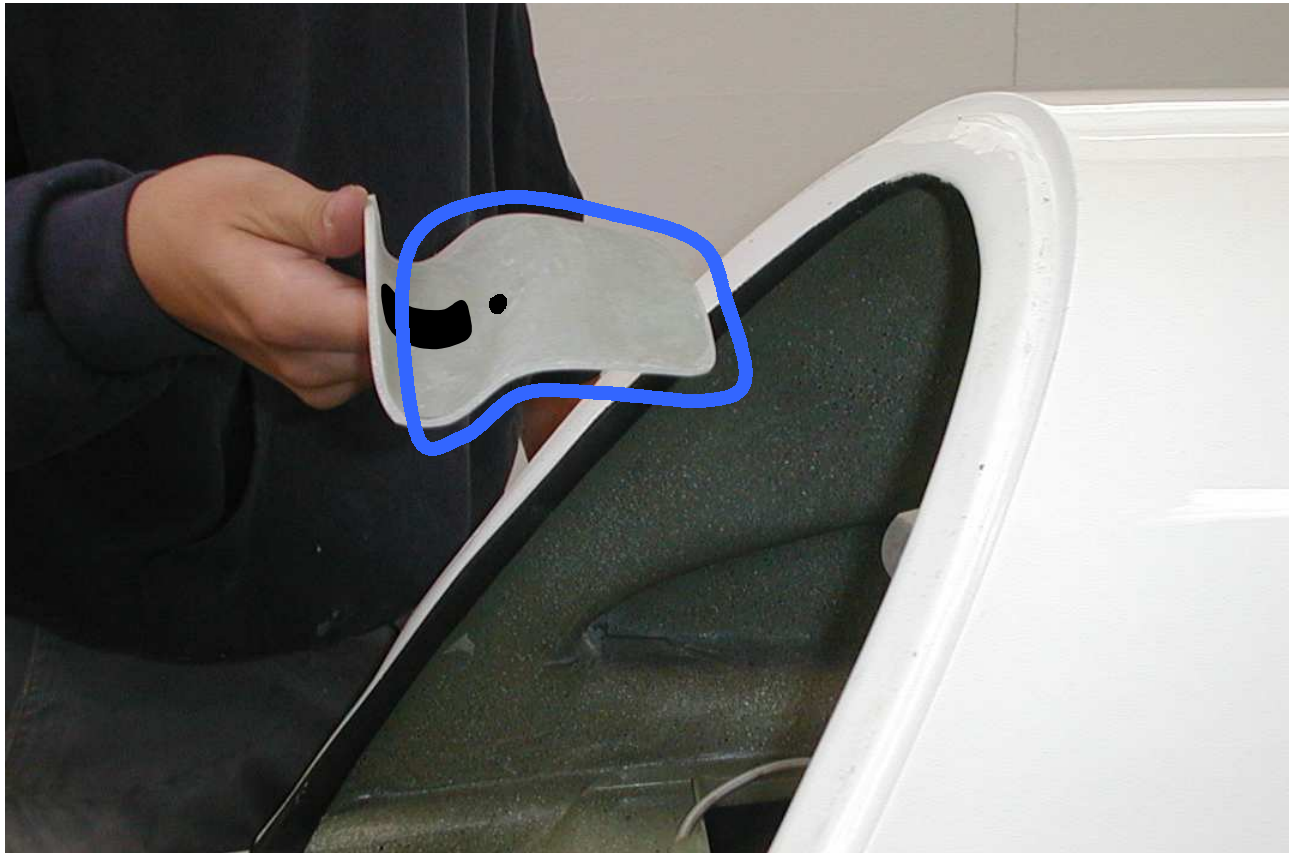
**Fig. 2: Preparation**

Close the canopy and check if the canopy-side canopy frame engages in part **S1 R1** without touching it or pressing on it. Lock the canopy.

If part **S1 R1** is touched by the canopy frame add spacers between fuselage wall and part until the the canopy frame does not touch it.

Now outline the position of the part inside the fuselage (e.g. with a pencil).

Remove any paint (if present) from the inside of the outline and sand the whole area thoroughly (grain size 60).

The area of the surface of part **S1 R1**, which will be glued to the fuselage, must also be thoroughly sanded (blue framed area in Fig. 2).

Apply the glue to the rear area of part **S1 R1** approx. 2-3mm thick (see blue framed area in Fig. 2) and glue the component to the upper fuselage.

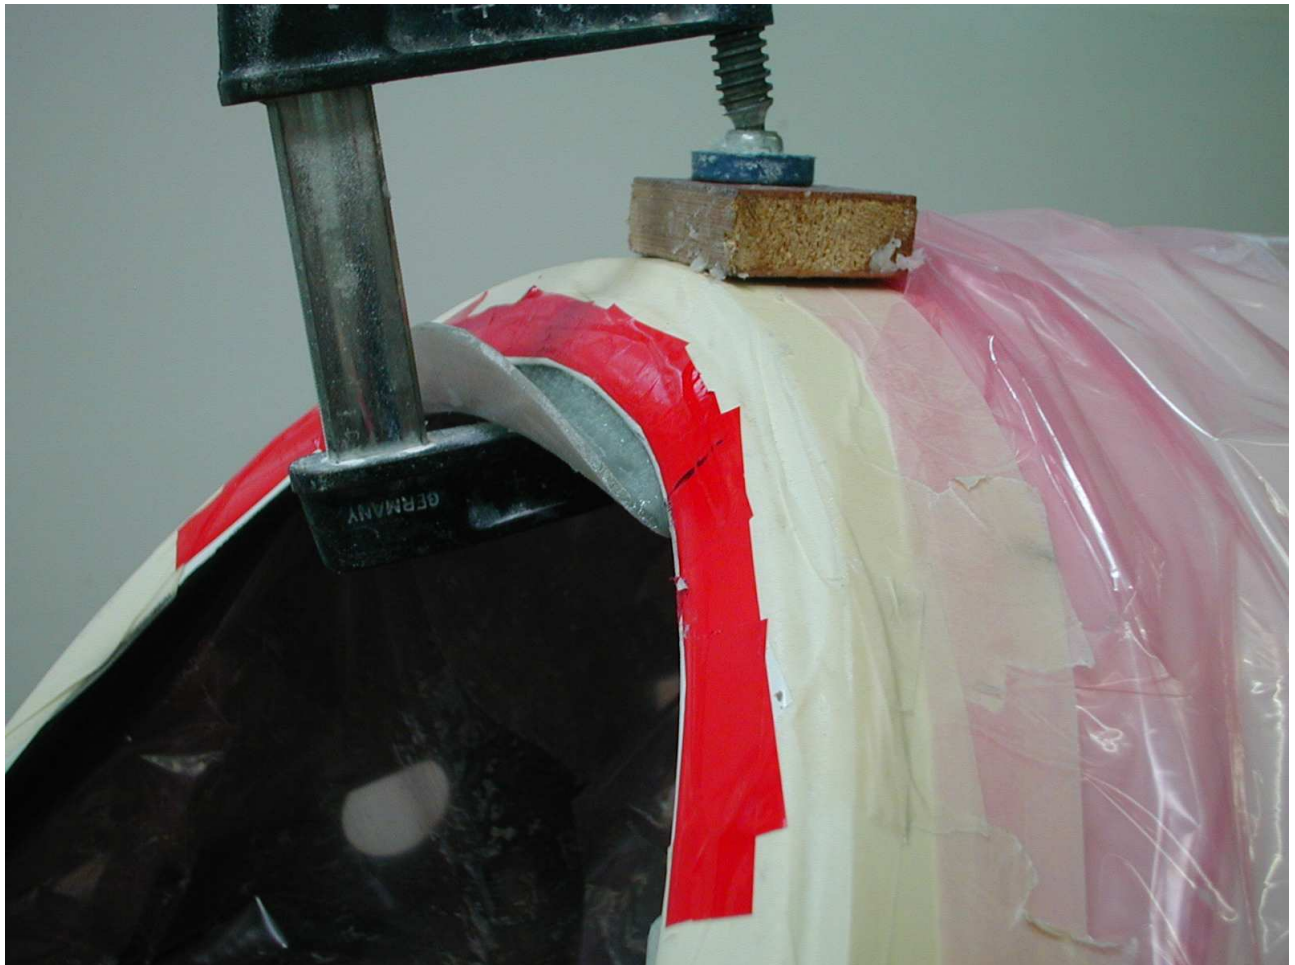
**Fig. 3: Glueing**

When the part is positioned correctly wall it can be fixed with a vice (underlay a piece of soft wood or hard foam if necessary) for curing. Take care not to move the part when tightening the vice!

Adhesive which oozes out when tightening the vice can be removed with a spatula. Check if the gap between part and fuselage is filled with glue all around so there is no hole. Do not tighten the vice so much that the fuselage wall will be deformed.

After hardening of the resin the vice can be removed.

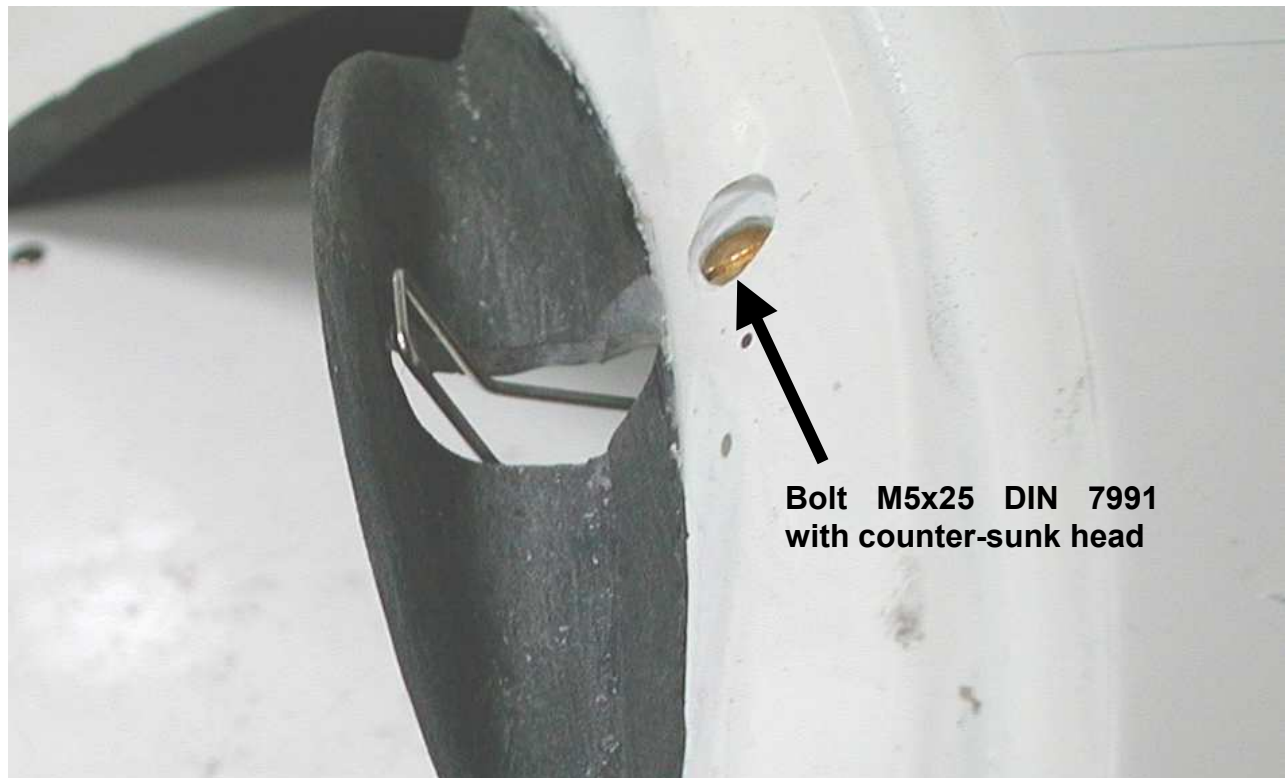
**Fig. 4: Completed installation (side view)**

The pre-drilled hole  $\varnothing 5\text{mm}$  in part **S1 R1** can now be used as a template for the hole which must be drilled through the fuselage-side canopy frame. To do so, drill through the hole from the baggage compartment to the outside. Countersink the outside opening of the

hole in the canopy frame so the head of the bolt M5 x25 DIN 7991 is completely counter-sunk (see Fig. 4). Due to the angle of the bore hole the head will not be flush with the canopy frame.

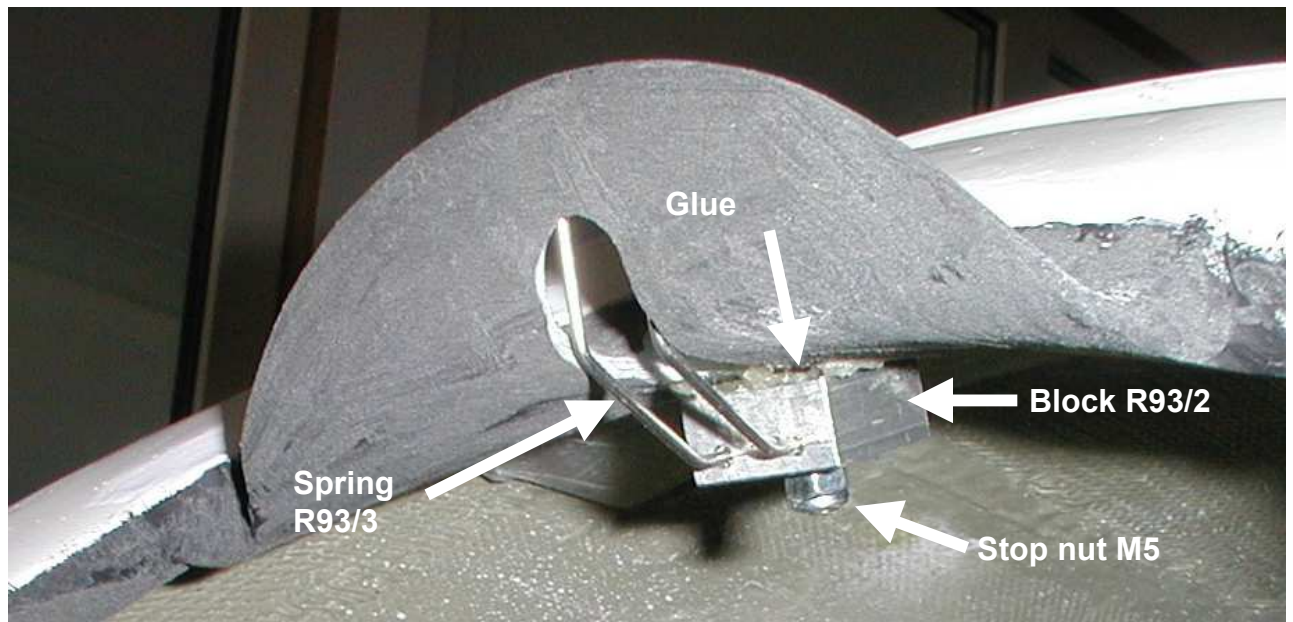
**Fig. 5: Completed installation (shown from below)**

Bolt together aluminium-block **R93/2** and spring **R93/3** with the canopy frame on a trial basis. Depending upon the thickness of the fuselage-side canopy frame and the depth of the countersink, the bolt M5x25 sticks out differently far inward from the block (see Fig. 5).

If there are not enough threads visible out of **R93/2** to fasten the locknut M5 DIN985 use either a longer bolt (e.g. M5x30 DIN 7991-8.8) or use a drop of Loctite 243 on the thread of the bolt to secure the bolt on final assembly.

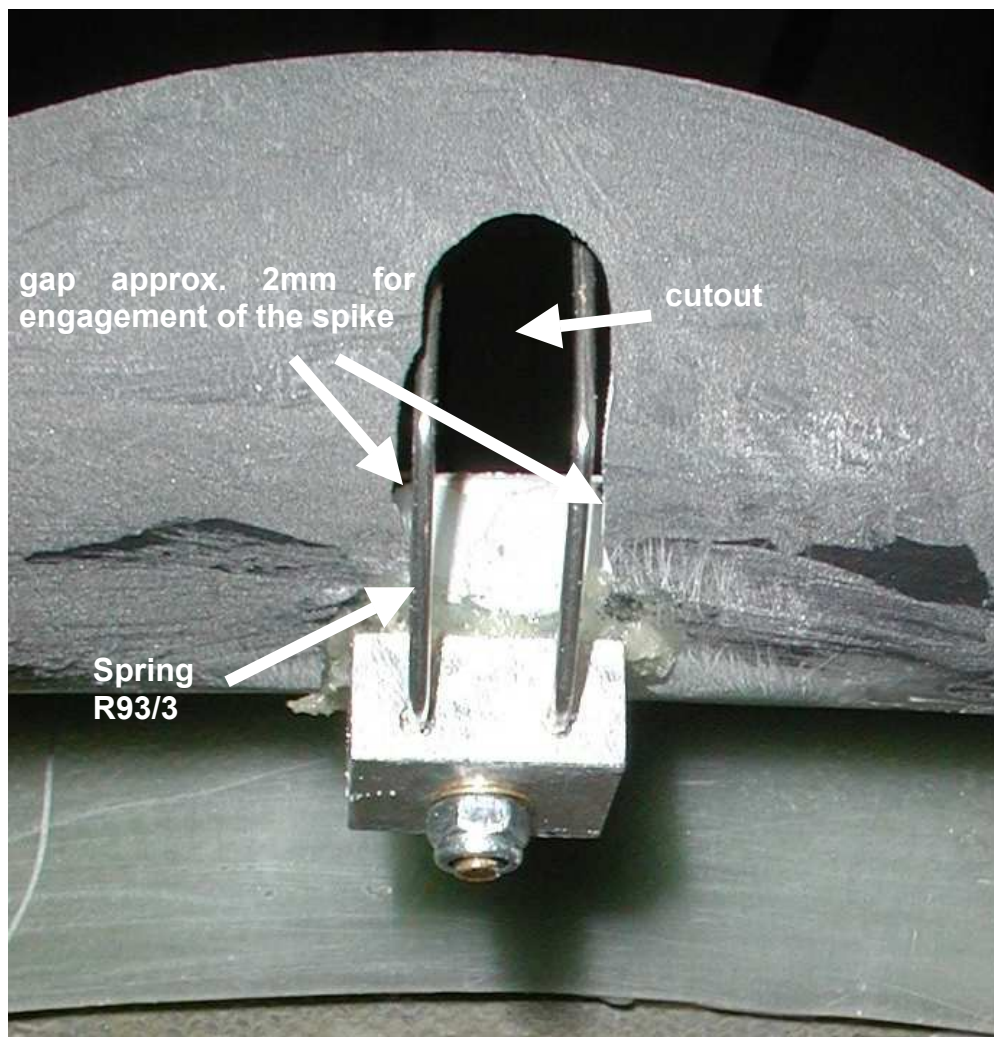
**Fig. 6: Completed installation (front view)**

Part **S1 R1** has a prepared cutout as shown in Fig. 6. Normally it shouldn't be necessary to enlarge the cutout. However it is necessary to check if spring **R93/3** has enough clearance to **S1 R1** on both sides, so the spring can be bent open enough when spike **R93/1** engages in the spring.

The cutout must not be enlarged to a degree which allows spike **R93/1** to fit left or right of the spring.

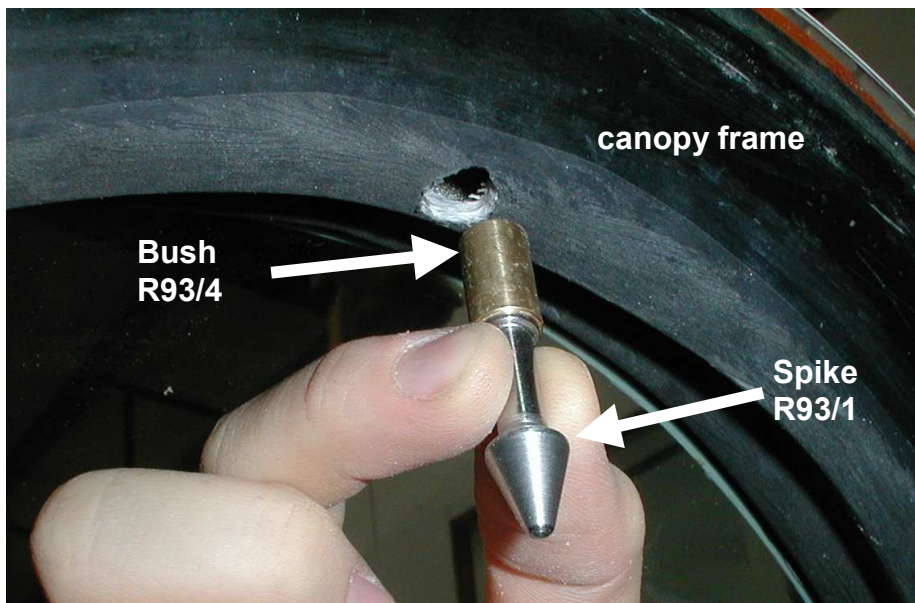
**Fig. 7: Hole in the canopy frame**

Sit in the cockpit, close and lock the canopy, drill a hole in the canopy frame in the center of the spring **R93/3** with 9mm diameter and 15mm deep. Be careful not to drill too deep! The hole should be drilled vertical or a bit from aft below to front up.

Screw spike **R93/1** in bush **R93/4**. Fill the hole with resin/hardener thickened with cotton flocks, push the bush into the hole. The bolt should be vertical (or point a little bit rearwards) and in the center of the spring **R93/3**. Allow to cure at room temperature.

The canopy frame is hollow, so be sure to use enough thickened resin to create a proper seat for the bush.

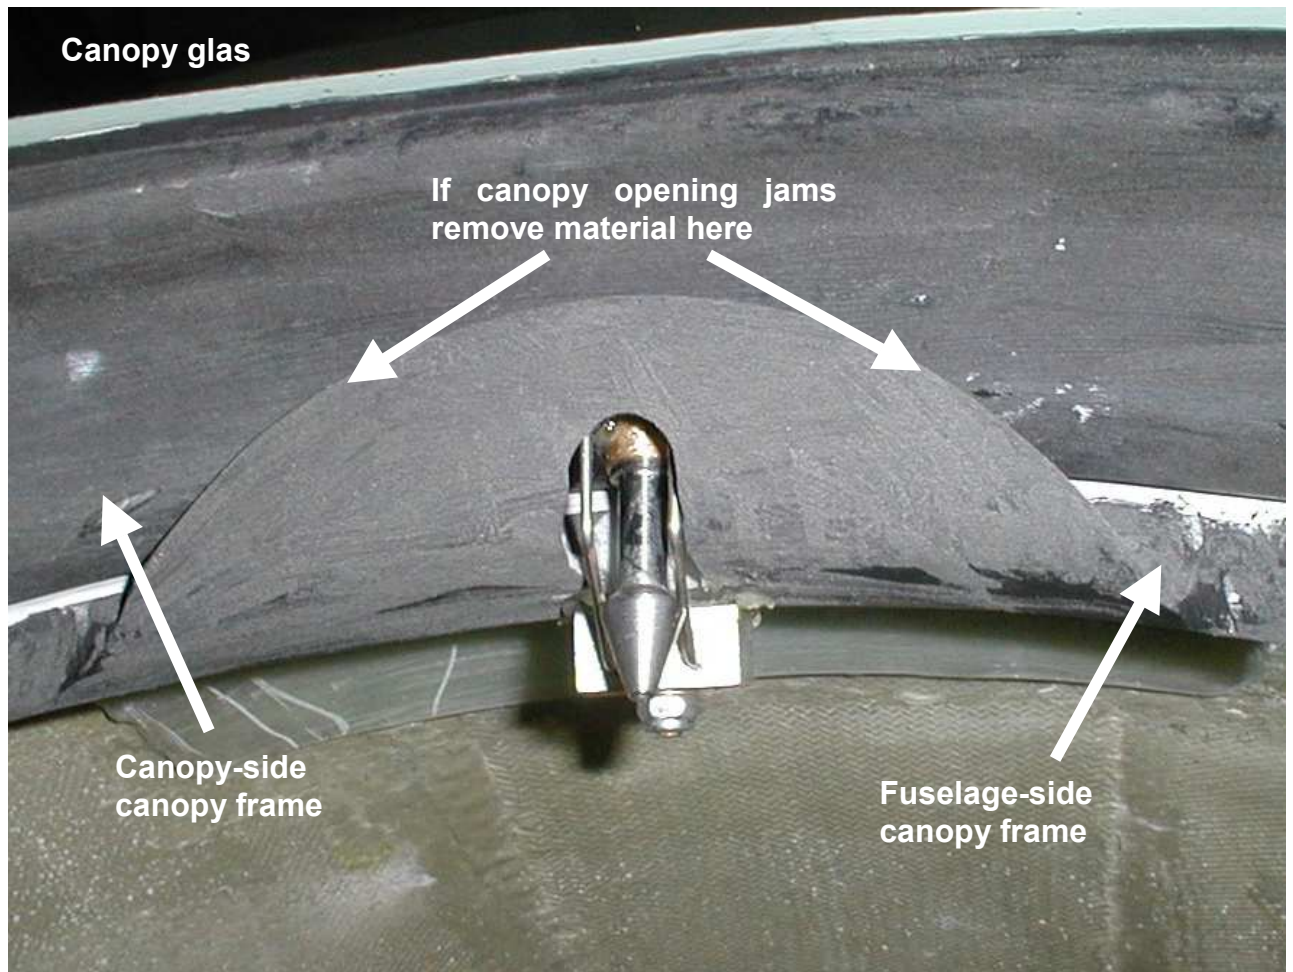
**Fig. 8: Canopy guide with closed canopy**

After curing check first if the canopy can be closed normally. If this is the case pull the canopy emergency release and try to rotate the canopy around the newly installed canopy guide in the back. It's advisable to do this with two people.

When doing so the spike must slide forward in the spring until it reaches the front end of the spring. Don't continue with the opening of the canopy - otherwise it is possible to lever the spike out of the canopy!

If the canopy jams in part **S1 R1** prior to the spike reaching the front end of the spring, it would be necessary to remove some material at the left and right front side of part **S1 R1** until the jamming is eliminated. (see Fig. 8)
