<b>E.Margański i Wspólnicy Zakłady Lotnicze</b>	<b>Enclosure No 1 to BO-112/2005 SWIFT S-1 Working Instruction Inspection of control column in elevator control system</b>	<b>SWIFT S-1</b>
---	--	------------------

Enclosure No 1  
to  
Bulletin No BO-112/2005 SWIFT S-1

**WORKING INSTRUCTION  
INSPECTION OF CONTROL COLUMN  
IN ELEVATOR CONTROL SYSTEM  
OF SWIFT S-1 GLIDER**

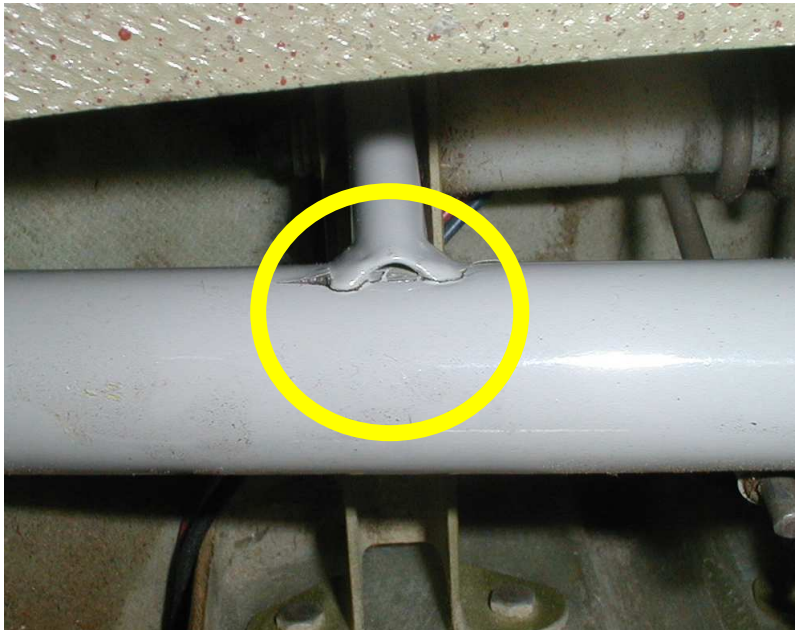
**picture 3: Damage viewed from front**

picture 3 and picture 4 show a sample of the possible damage.

- I) Dismantle the control stick cover and remove the left (in flight direction) access cover of the controls close to the control stick (s. picture 1).
- II) Inspect the welding seams of the attachments (see circles in picture 2) over the whole length for cracks and other damage; use a strong pocket lamp and a mirror - if necessary. If crack or other damage is found, the control column must be replaced.

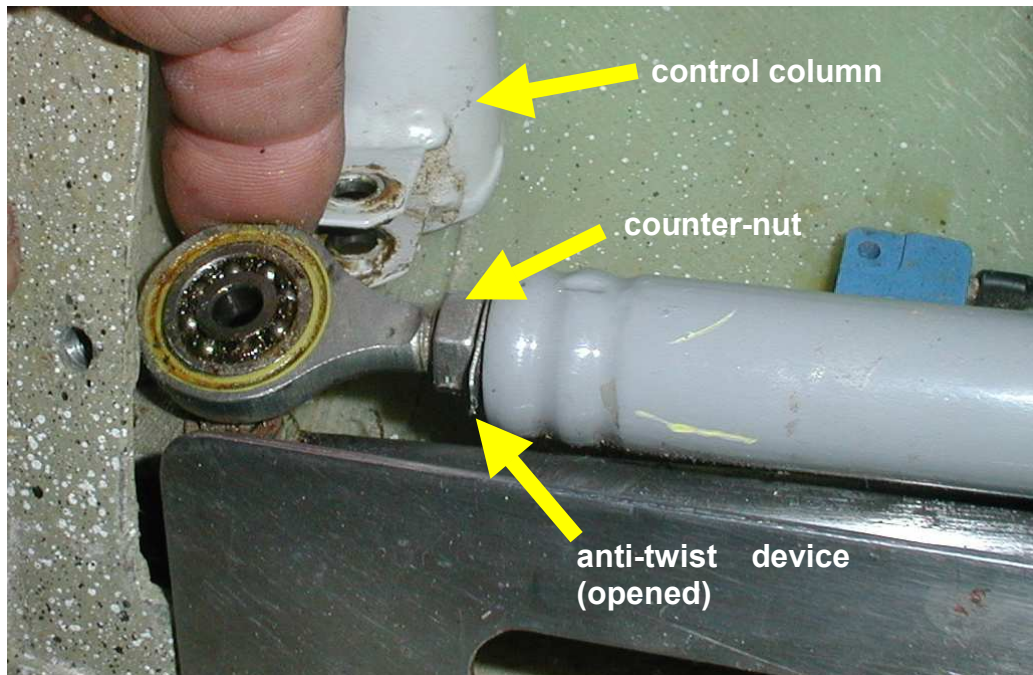
**picture 8: Swivel-head disconnected and counter-nut untightened**

To do so, untighten and disconnect the bolt M6, one connecting the push rod end with the column, mark the positions of the washers and keep all these items. Bend off the anti-twist lock at the counter-nut (sheet metal clip), unthighten the counternut and screw the swivel head into the pushrod until the elevator deflections in „nose down“ direction reach the required value (see picture 7 and picture 8).
